Manhole Inspection Summary

Manhole # S29MM1076MH

Location Address: **4413 ATWICK RD** Cross Street: **COLDSPRING LN**

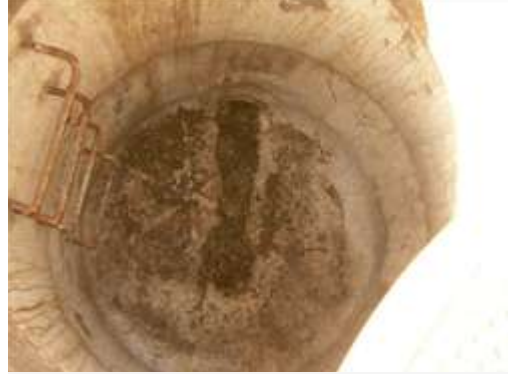
Top View

Corroded steps. Channel debris.

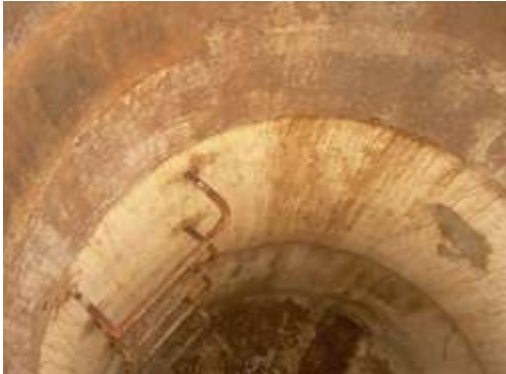
Defect

Frame leaks. Adjustment and Barrel infiltration.

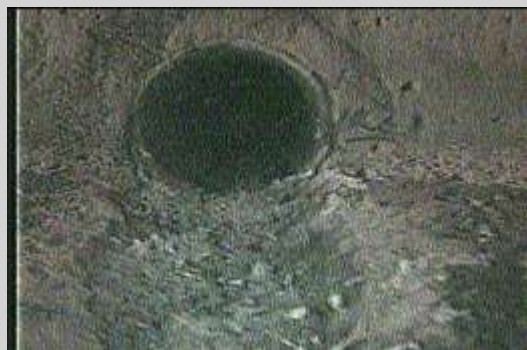
Pipe Out @ 12 O'Clock

Deposits: ☐ None ☒ **Mud** ☐ Sludge ☒ **Debris** ☐ Grease

Infiltration: **Evidence**
